Debris/Ice/TPS Assessment and Integrated Photographic Analysis of Shuttle Mission STS-85

*Gregory N. Katnik
Process Engineering/Mechanical System Division/ET-SRB Branch,
Kennedy Space Center, Florida*

**DEBRIS/ICE/TPS ASSESSMENT
AND
INTEGRATED PHOTOGRAPHIC ANALYSIS
OF
SHUTTLE MISSION STS-85**

7 August 1997

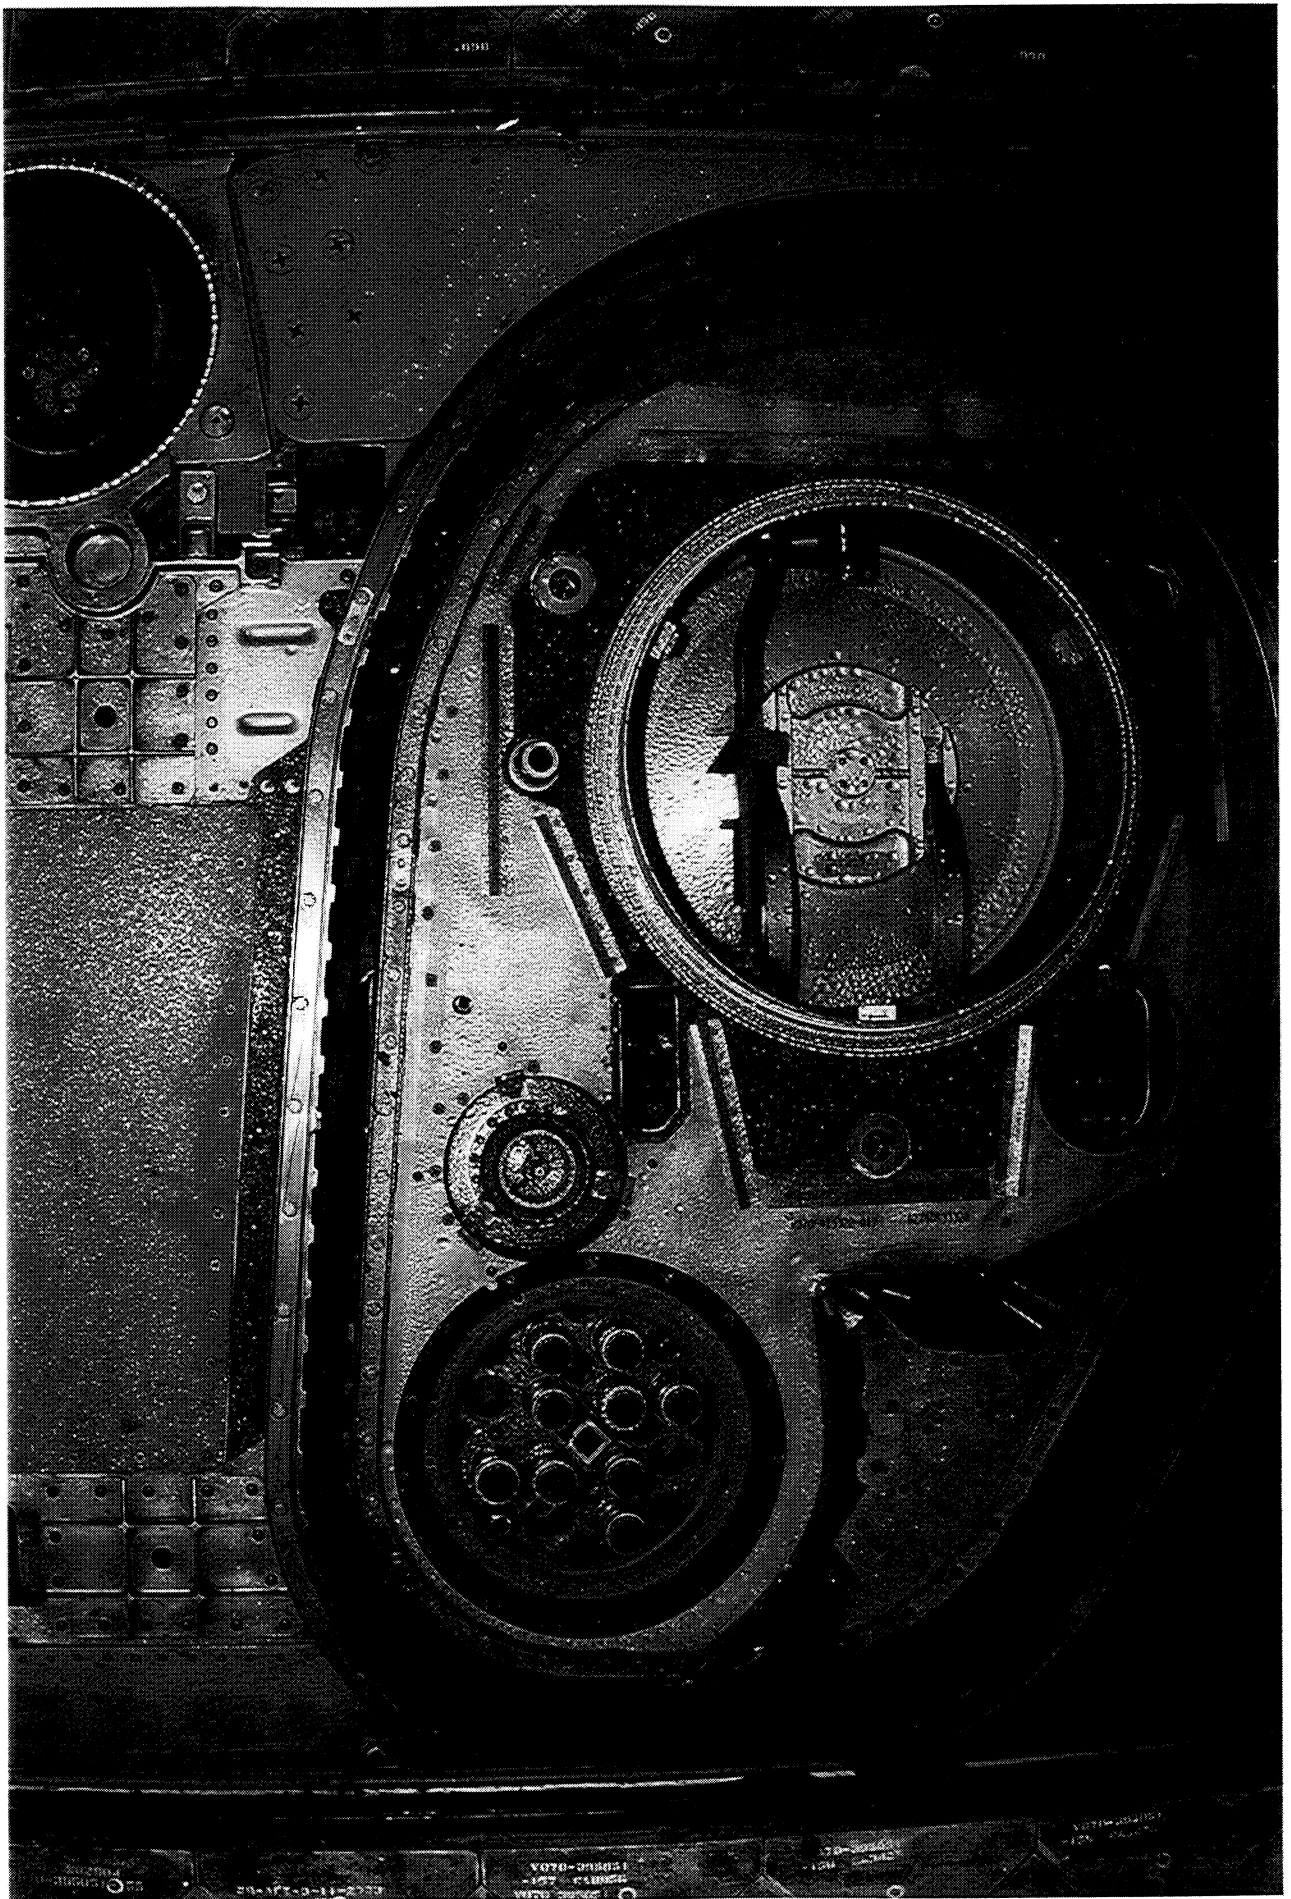
Photo 21: LO2 ET/ORB Umbilical

No leaks were observed on the GUCP or the LO2 and LH2 Orbiter T-0 umbilicals.

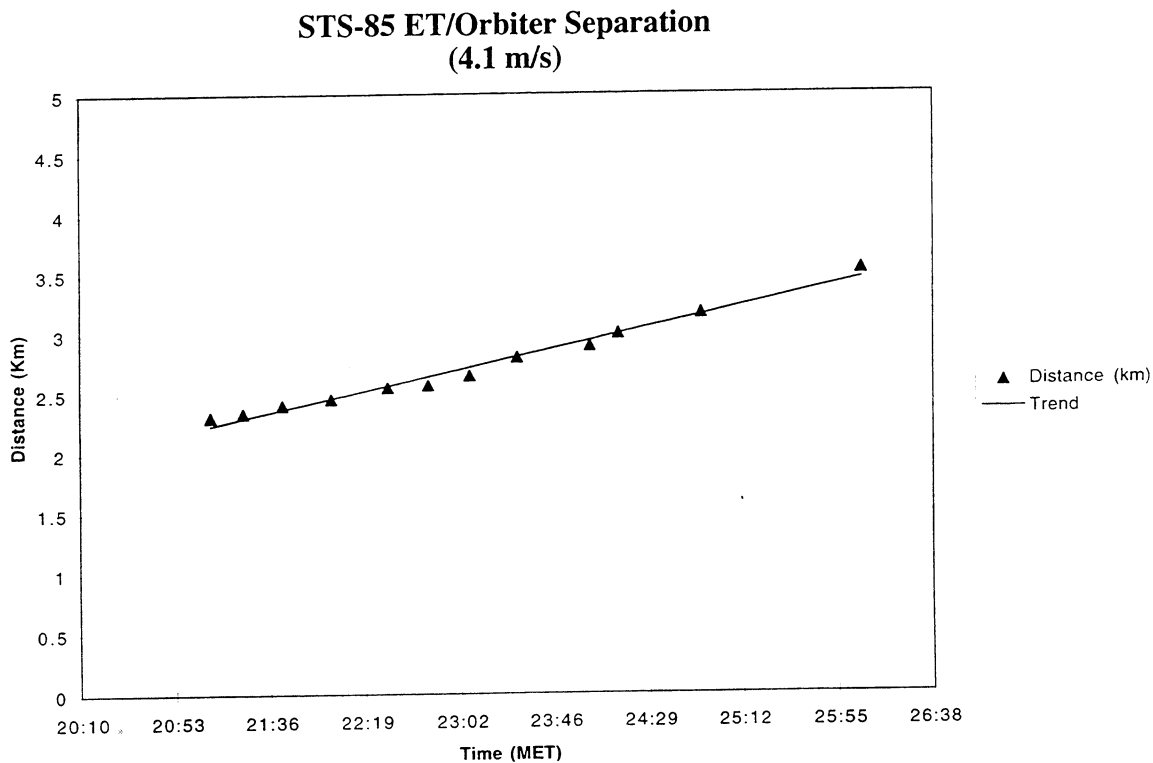
Figure 2.5.2 ET Separation Velocity

The distance of the external tank was calculated on 12 frames. On the first view used, the external tank was calculated to be a distance of 2.3 kilometers away from the Orbiter at 21:09 MET. On the last view, the tank was calculated to be at a distance of 3.5 kilometers (4 minutes, 57 seconds after the first view). The tank separation average velocity was determined to be 4.1 meters/second (m/s), with an uncertainty of approximately 1 m/s. The tank tumble rate was approximately 0.4 degrees/second. The tank roll rate was approximately 0.3 degrees/second.

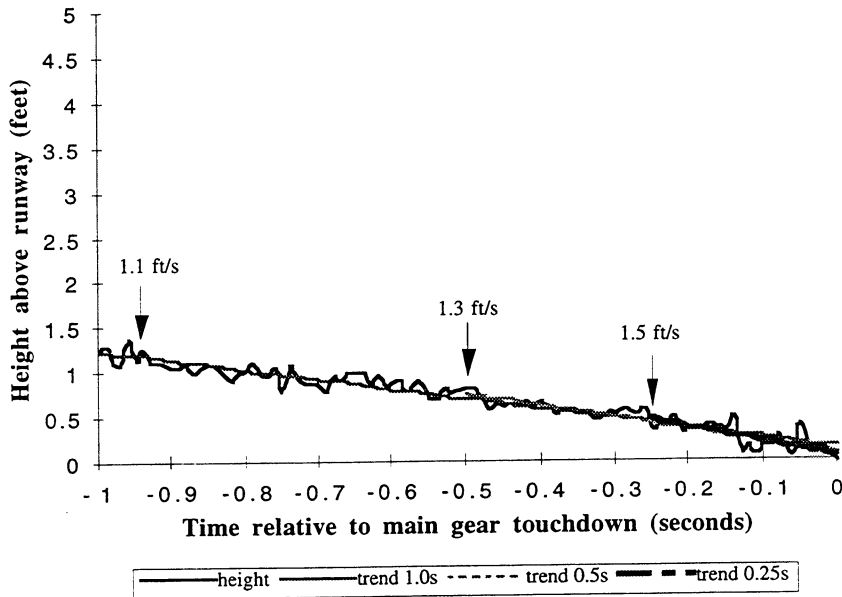
Figure 2.6.1 (A) Main Gear Height versus Time Prior to Touchdown

The measured main gear sink rate values were found to be below the maximum allowable values of 9.6 ft/sec for a 211,000 lb. vehicle and 6.0 ft/sec for a 240,000 lb. vehicle (the landing weight of the STS- 85 Orbiter was reported to be 221,184 lbs.). The sink rate measurements for STS-85 are given in Table 2.6.1. In Figure 2.6.1(A), and 2.6.1(B), the trend of the measured data points for the image data is illustrated.
